**Flood Control Project Maintenance
Levee Inspections**

Maintenance Issue Types Only, Levee Inspection Report By Mile - Spring 2017

Sutter Maintenance Yard Maintenance Area 0016

Waterway	Bank	Unit Miles	Inspection Start/End	Inspector
Unit No. 01 Feather River	Right	4.06	03/23/2017 03/23/2017	Sterling York

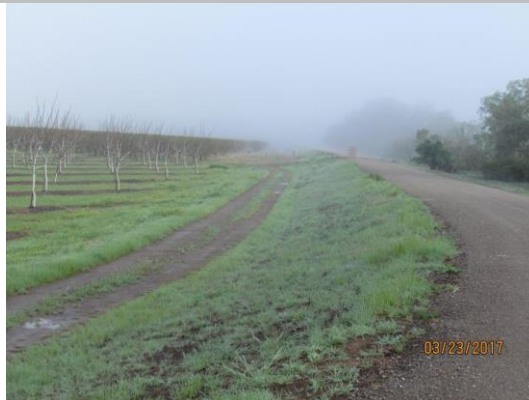
Photo 1 of 1 : SP_2017_MA0016_302_10_20170327_00014.jpg

LM Start	3.19	Rating **	A/W	Issue No.	10
LM End	3.65	Issue Type +	Ma	Location *	LS
Category	Earthen Levee			GPS Latitude/Longitude	
				Start	End
Item	Vegetation			39.298312 °	39.305053 °
				-121.638327 °	-121.637729 °
DWR ID	DWR_MA0016_01_f_2016_10				
Comment Code					
V1 : Control annual grass and weeds on the levee slopes and easements.					
Inspector Comment					
Annual grasses are maintained.

View looking upstream, landside, of annual grasses that are maintained.
Spring 2017.

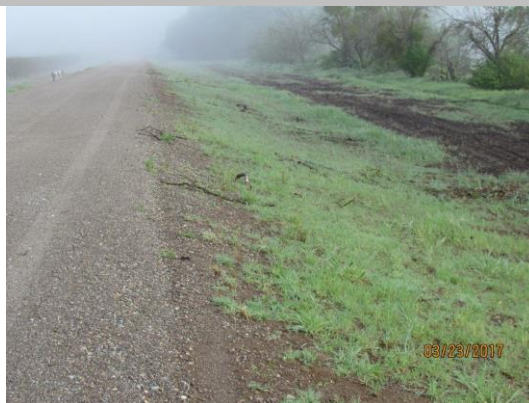
Photo 1 of 1 : SP_2017_MA0016_302_9_20170327_00015.jpg

LM Start	3.19	Rating **	A/W	Issue No.	9
LM End	3.81	Issue Type +	Ma	Location *	WS
Category	Earthen Levee			GPS Latitude/Longitude	
				Start	End
Item	Vegetation			39.298312 °	39.307293 °
				-121.638328 °	-121.637671 °
DWR ID	DWR_MA0016_01_f_2016_9				
Comment Code					
V1 : Control annual grass and weeds on the levee slopes and easements.					
Inspector Comment					
Annual grasses are maintained.

View looking upstream, waterside, of annual grasses that are maintained. Spring 2017.

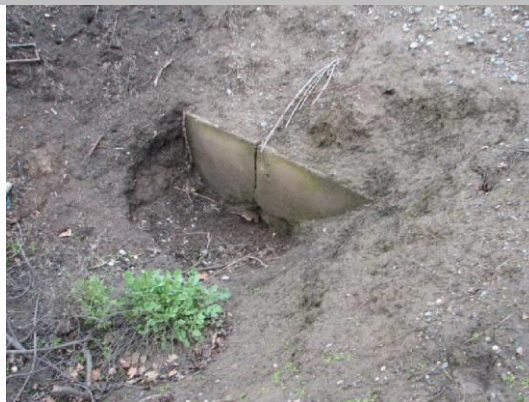
Photo 1 of 2 : UCIP_SP_2017_51157_65782.jpg

LM Start	3.39	Rating **	M	Issue No.	16
LM End	3.39	Issue Type +	Ma	Location *	WS
Category	Supplemental			GPS Latitude/Longitude	
				Start	End
Item	DWR UCIP LMA Responsibility			39.301218 °	39.301218 °
				-121.638332 °	-121.638332 °
DWR ID

Comment Code					
Inspector Comment					
FS_ID:51157 DS_ID:17125 EP_NO: N/A Repair Type: Non-Urgent Crossing Status: Found UCIP Comments: 12/1/2016 LS inlet completely buried. (DWR Sutter Yard- A Freitag)5/26/2016 LS inlet was completely buried.6/8/2015 Concrete headwall is still cracked and inlet is buried. It was said to be replaced with the SBFCA project but the project skipped over in this area.12/29/2014 Same as last inspection.5/19/2014 Same as last inspection.11/6/2013 Same as last inspection.5/14/2013 SBFCA project recommends replacing in accordance with title 23. Same as last inspection.12/11/2012 Concrete headwall on LS toe is cracked through middle and pipe is buried in soil. pipe appears corroded. FIELD_STRUCT_DESC: 1 of 2: 24-inch corrugated metal drainage pipe through the levee, 16.6 feet below the crown. Concrete headwalls on both the waterside (WS) and landside (LS) ends. Flap gate on the WS end. [Additional Reference(s): DWR Levee Log, 2005. USACE Sacramento O&M Manual 148, August 1955 (Station 646+96)]. FS Date: 12/2/2016 10:08:55 AM

Headwall at LS toe is cracked and the inlet is buried in soil.
